# Project Cheesebox

A journey into history

Volume Three

Research Manuscript  
United States Naval Academy  
1974

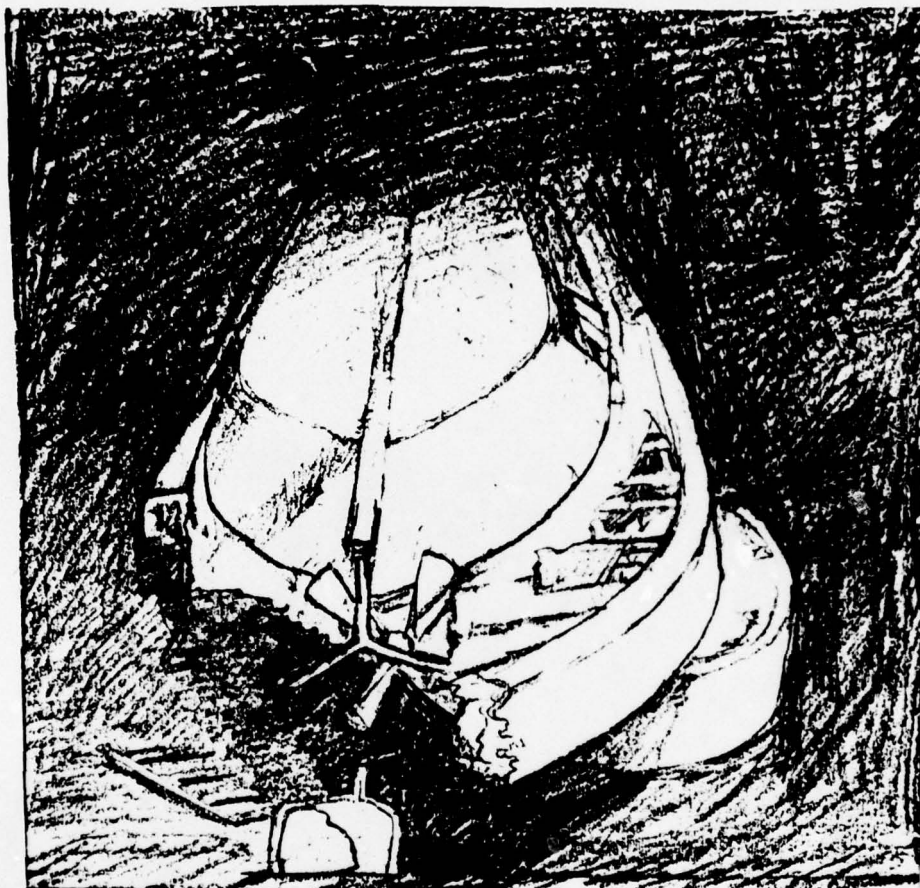
Figure 8. Artist's composite sketch from videotapes showing stern of capsized wreck at Site 2; the rudder is detached and resting on the sea floor.

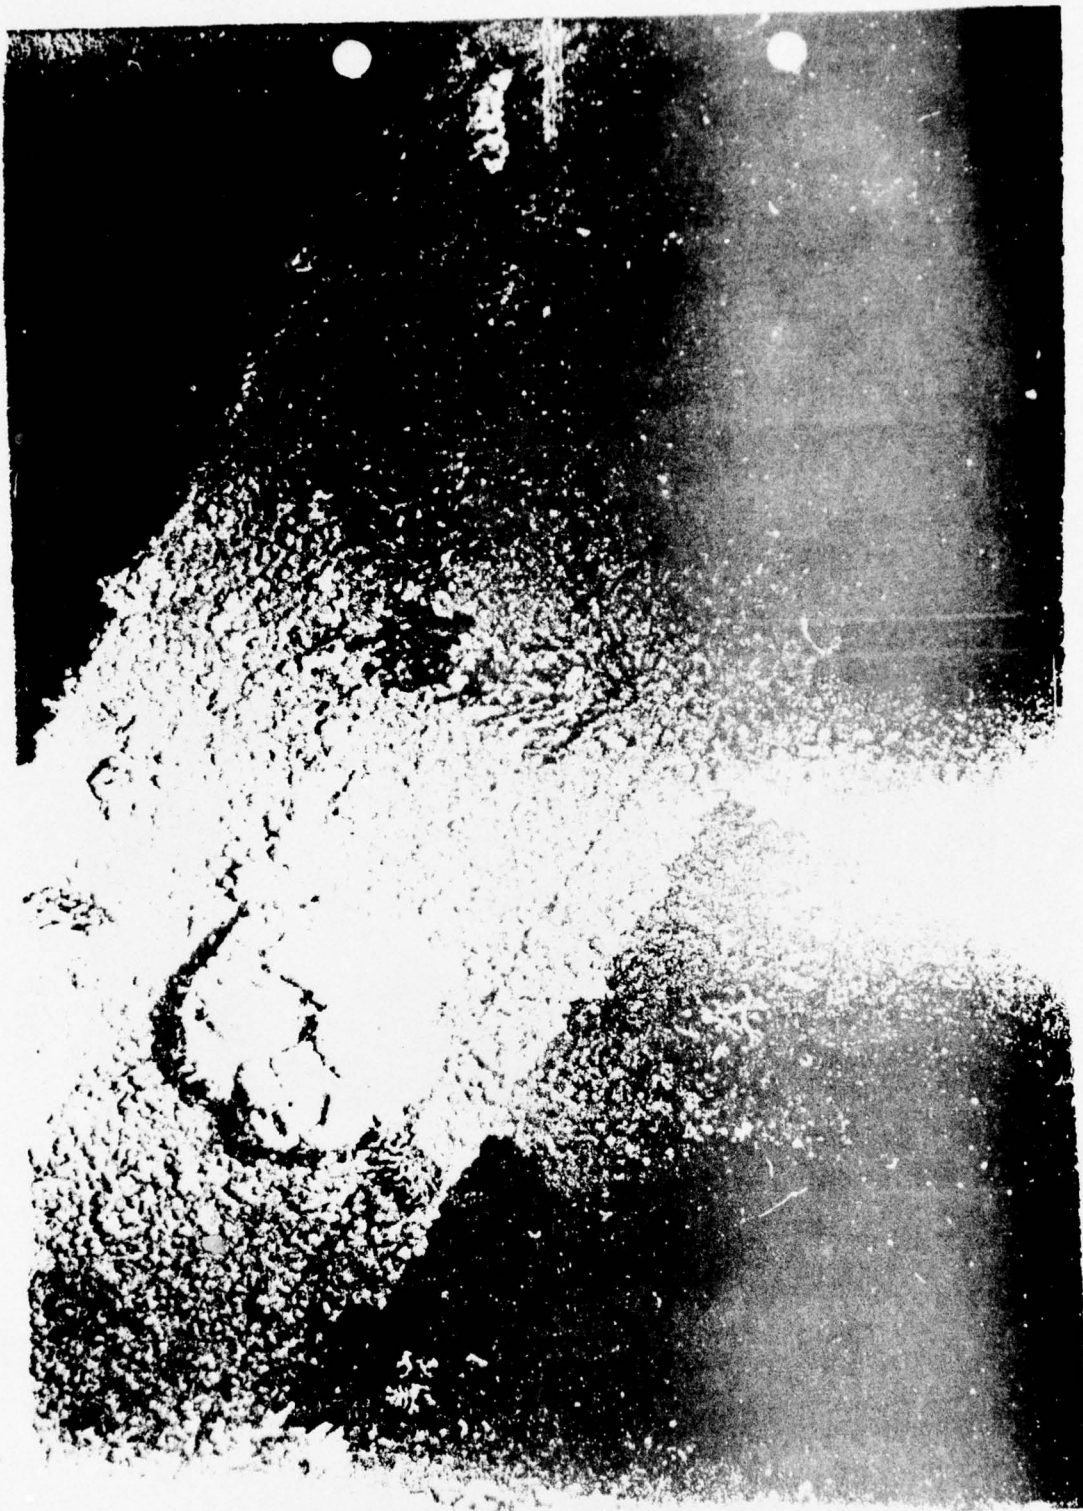
Figure 9. Wreck Site 2, photograph of the armor belt taken by EG&G Model 204, 205 underwater camera. The camera and pinger are now resting inside the hull of the wreck!

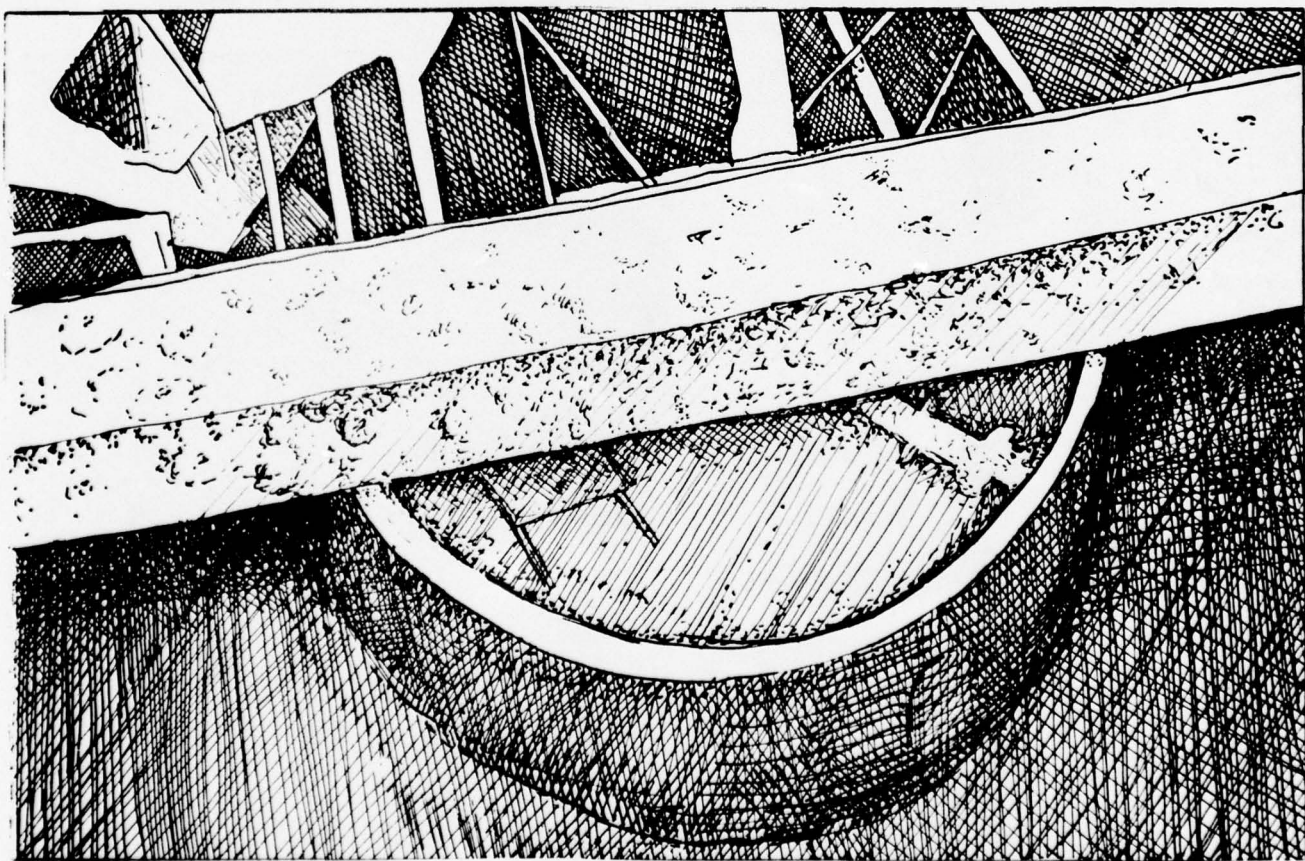
Figure 10. Wreck Site 2, photograph from videotapes of a portion of the turret (above) composite sketch of surrounding structures (below).

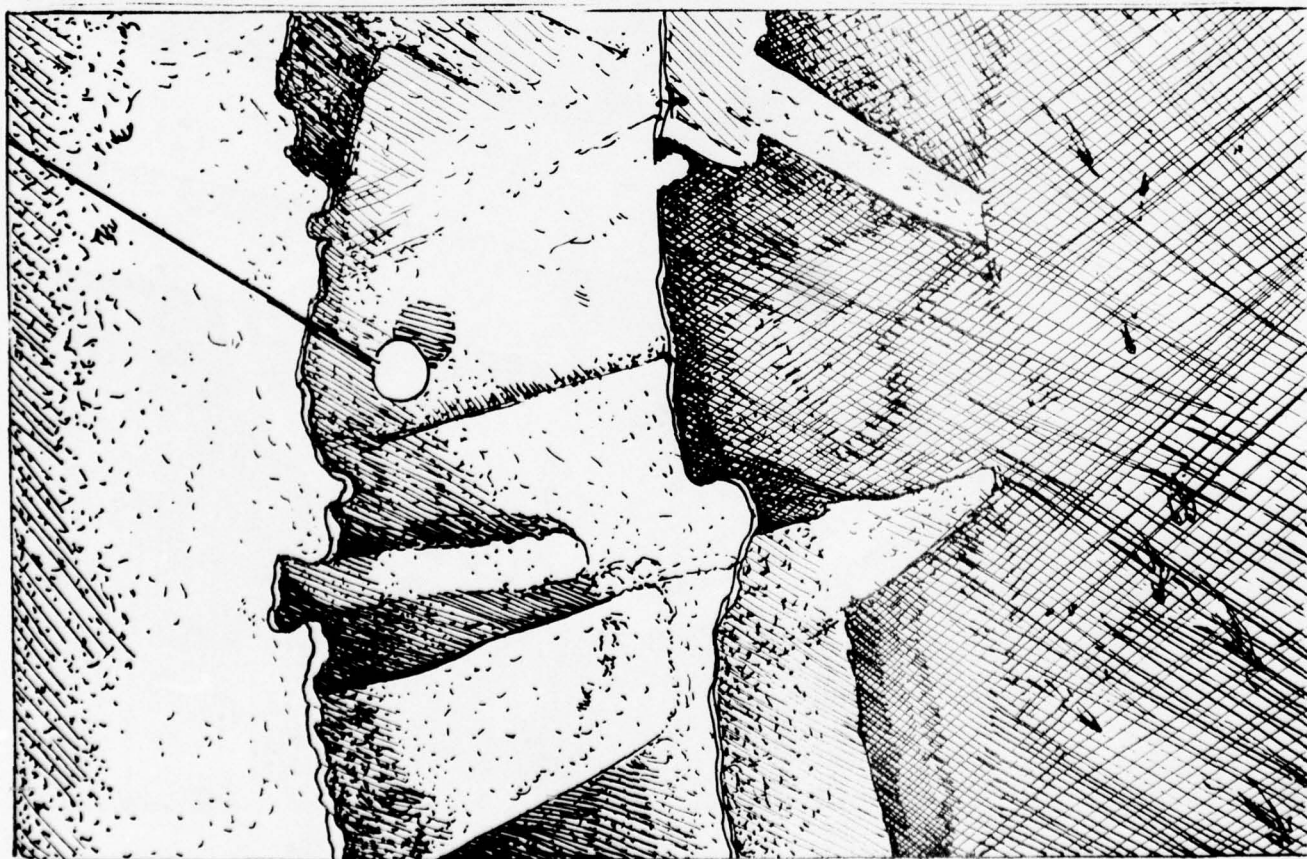
Figure 11. Photograph from videotapes of bilge and support stanchions to main deck (above), sketch of surrounding structures (below).

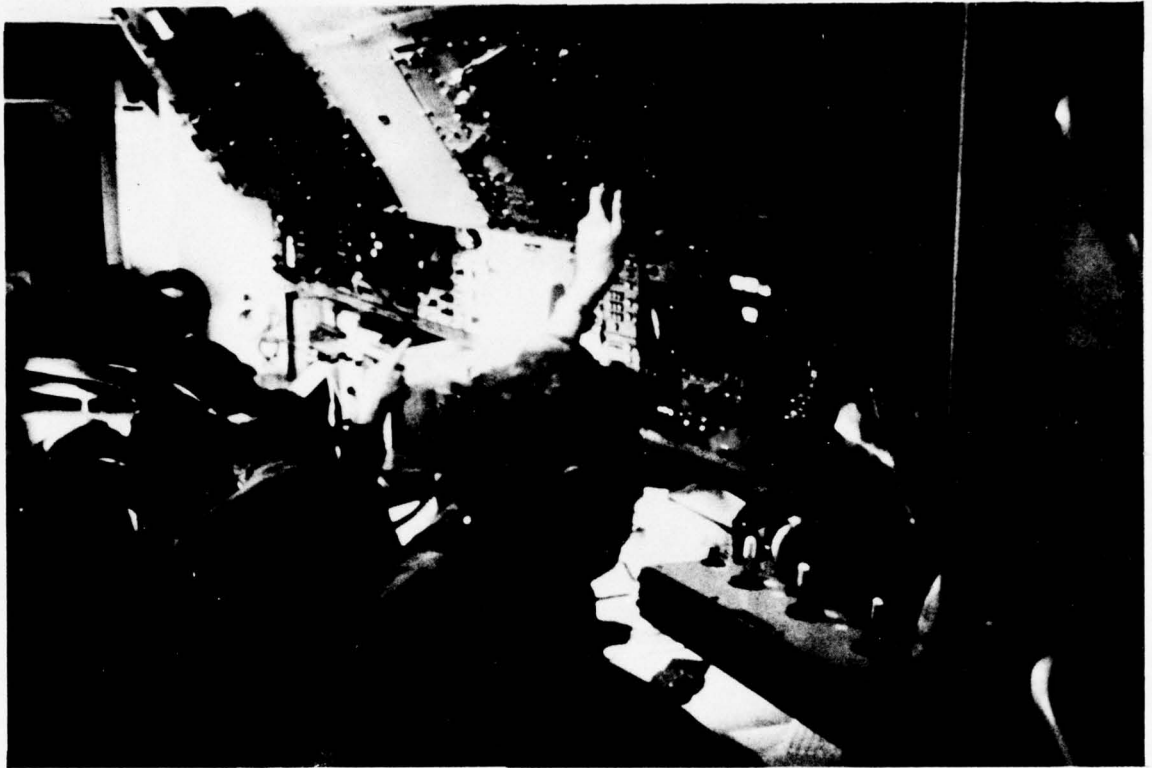
Interior of RP-3D Aircraft Used in Airborne Magnetic Survey  
Showing Scientific Area with Digital Readouts and Computerized  
Survey Equipment.

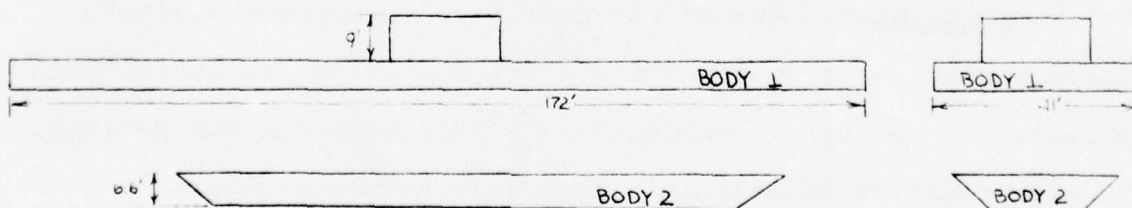
5.2.2 It should be noted that because the Monitor hull form is so irregular, it was separated into two separate forms to facilitate hydrostatic calculations.

After the calculations for the separate bodies were completed, the parameters were combined in order to obtain the parameters for the entire ship.

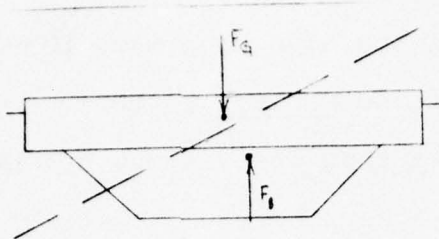
FIGURE 8

6.3.1 Upon displacing a vessel, the shape of the underwater body changes. Consequently the position of the center of buoyancy changes, and the center of gravity and buoyancy are no longer in vertical alignment.

A vessel in a stable condition will develop a moment which tends to right the vessel. The magnitude of the developed moment gives an indication of the quickness with which the vessel will be righted. In other words, the magnitude of this moment determines the severity of the response of the vessel.

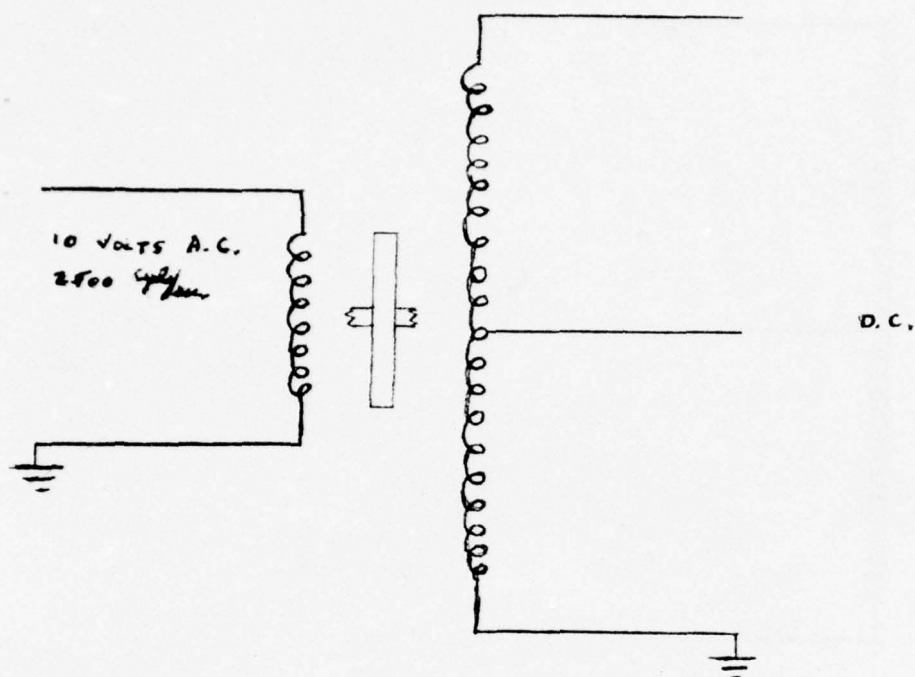
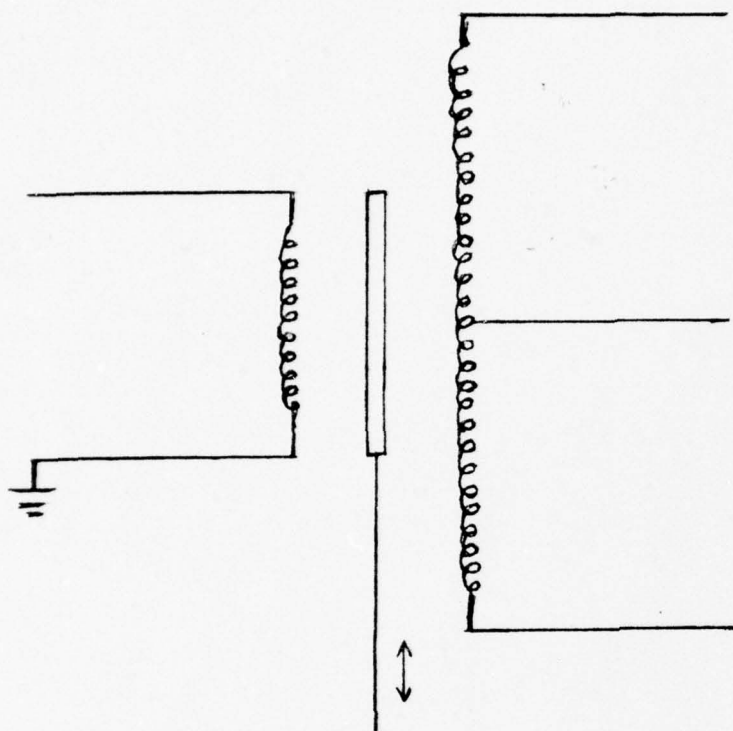
# ROTARY VARIABLE DIFFERENTIAL TRANSFORMER

OUT PUT VOLTAGE	
10° - .252	-10° - .250
20° - .501	-20° - .502
30° - .752	-30° - .758
40° - .998	-40° - 1.000

SANBORN LINEAR SYN DIFFERENTIAL  
TRANSFORMER  
585 DT - 050

6.4.2 These two parameters are sensed and measured by means of two rotary variable differential transformers. They are excited by a 10 volt A.C. current with a frequency of 2500 cycles per second. This coupled with the movement of the rotor caused by the movement of the force block attached to the model induces a current in the secondary coils where the A.C. is rectified to D.C. current. This current is sent to a small patch panel on the carriage assembly where it is linked to the Gould Brush Recorder (USNA No. 2327-3072). The output voltage is a function of the amount of rotation of the rotor.

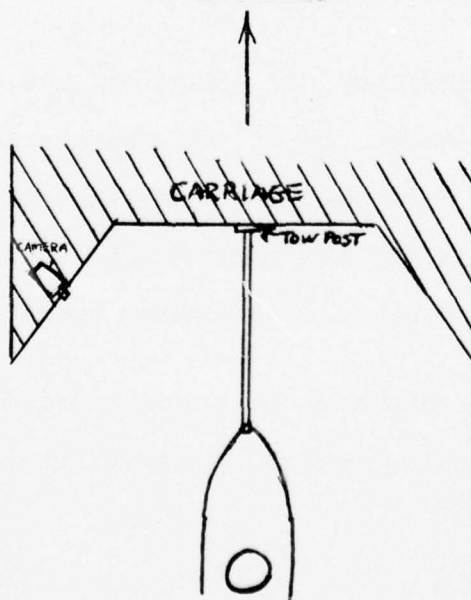
7.3.5 The camera was located above and to the port side of the model as shown below.

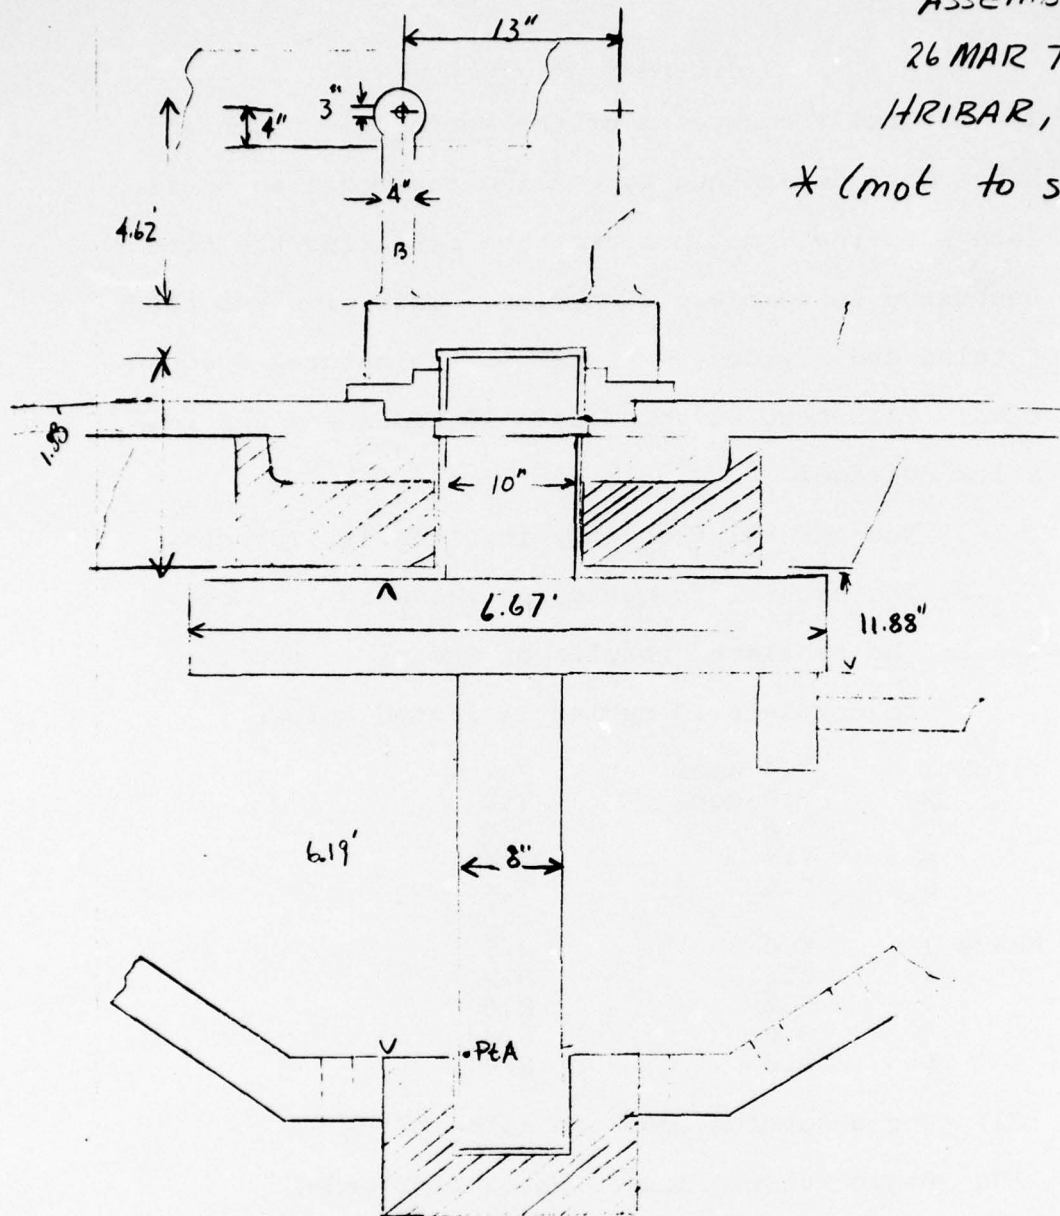
# STRUCTURAL ANALYSIS OF TURRET ASSEMBLY

- I. Case A, assume pins will hold load; will the shaft hold the load of the turret?

8.6.1 Assuming the above conditions the stress to which the shaft was subjected was found to be 4.46 ksi. This is significantly less than the ultimate tensile strength of the material.

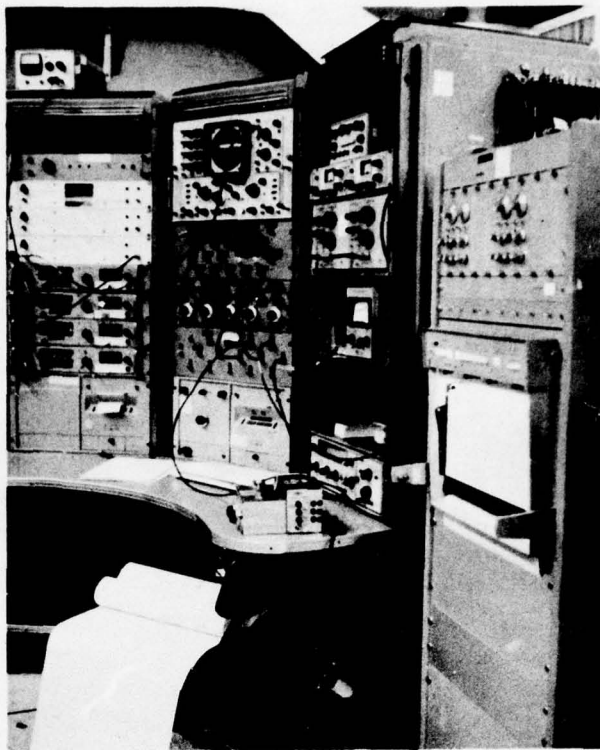
Figure E-3

Strip Chart Recorders

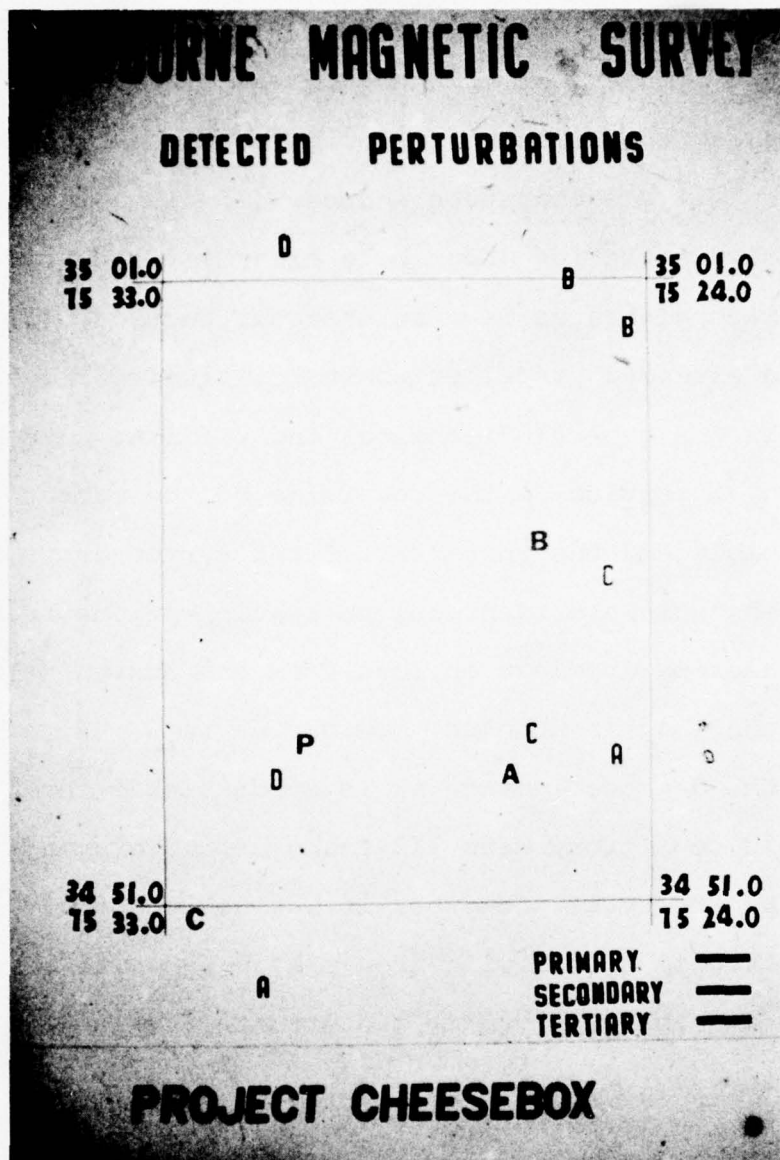
Airborne Magnetic Survey Results of the 17 January 1974  
Flight. Courtesy W. J. Andahazy

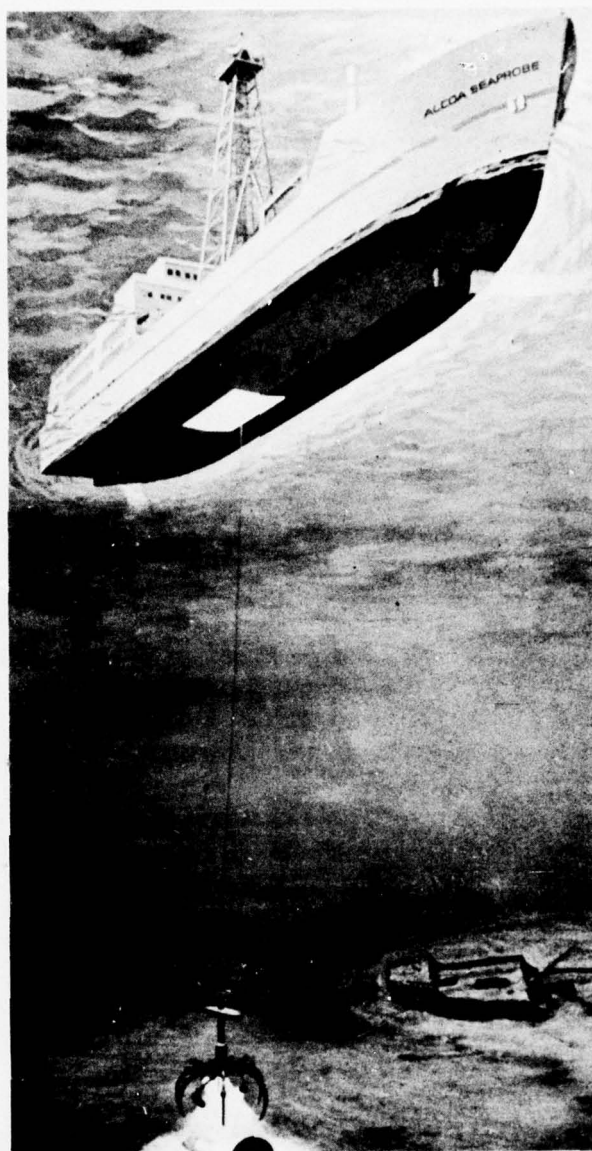
Seaprobe Concept Showing the Cycloidal Propellers, Fore and Aft and the Semi-rigid Drill Pipe String Being Lowered from the Deck Mounted Derrick, Lowered through a Center Well in the Ship's Hull to the Ocean Floor and the Survey Site.

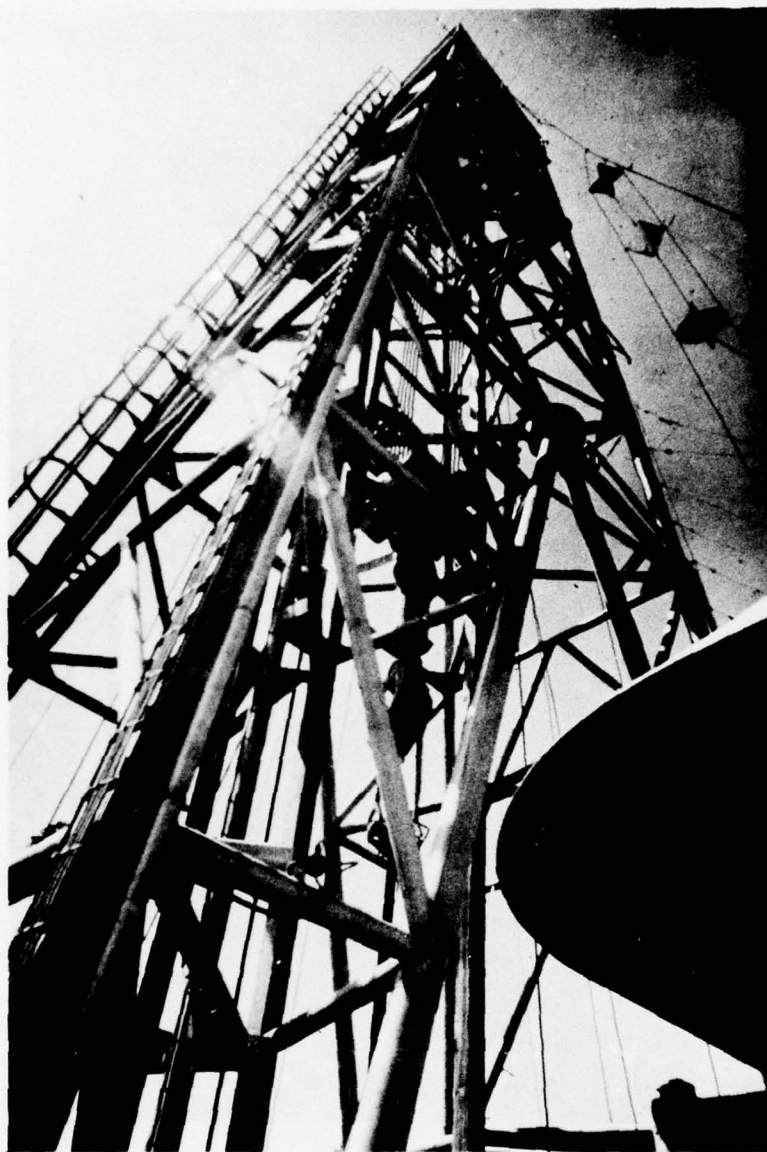
The Drill Pipe String is Raised into the Derrick by the Multi-ton Coupling.

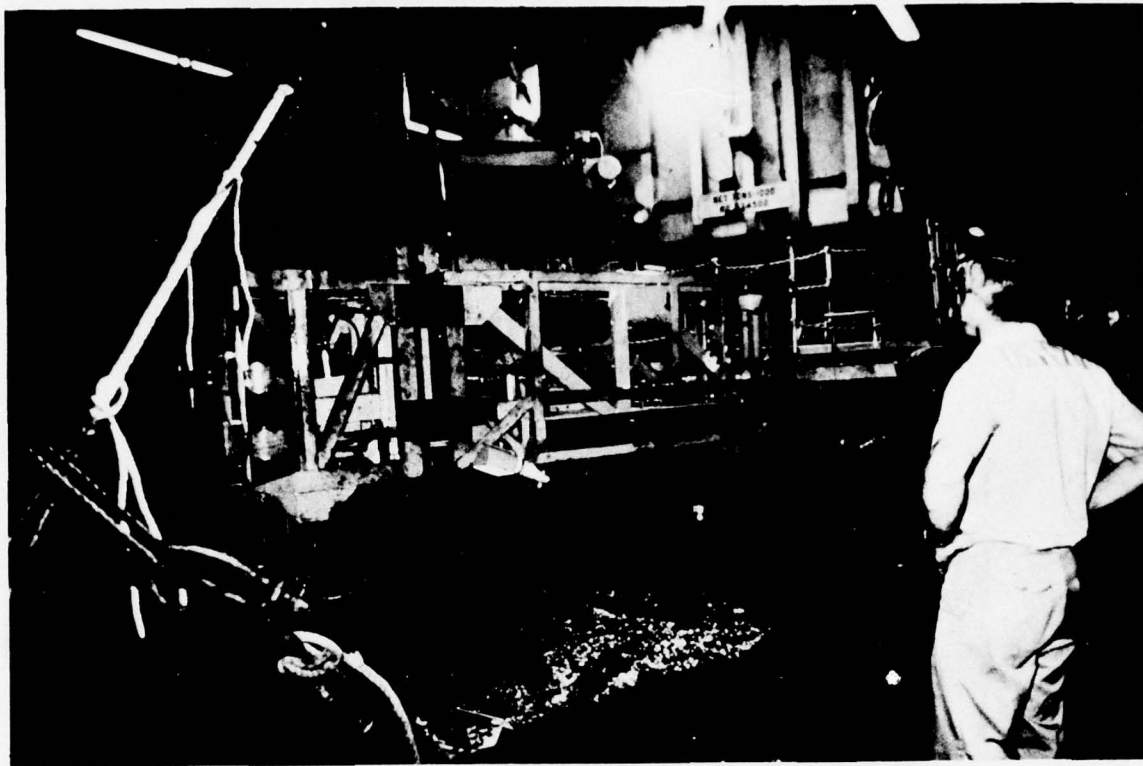
Instrument Pod Raised into the Well Deck of the Alcoa Seaprobe. The Instrument Pod is a Steel Frame Which Carried all the Search, and Photographic Equipment for the Operation.

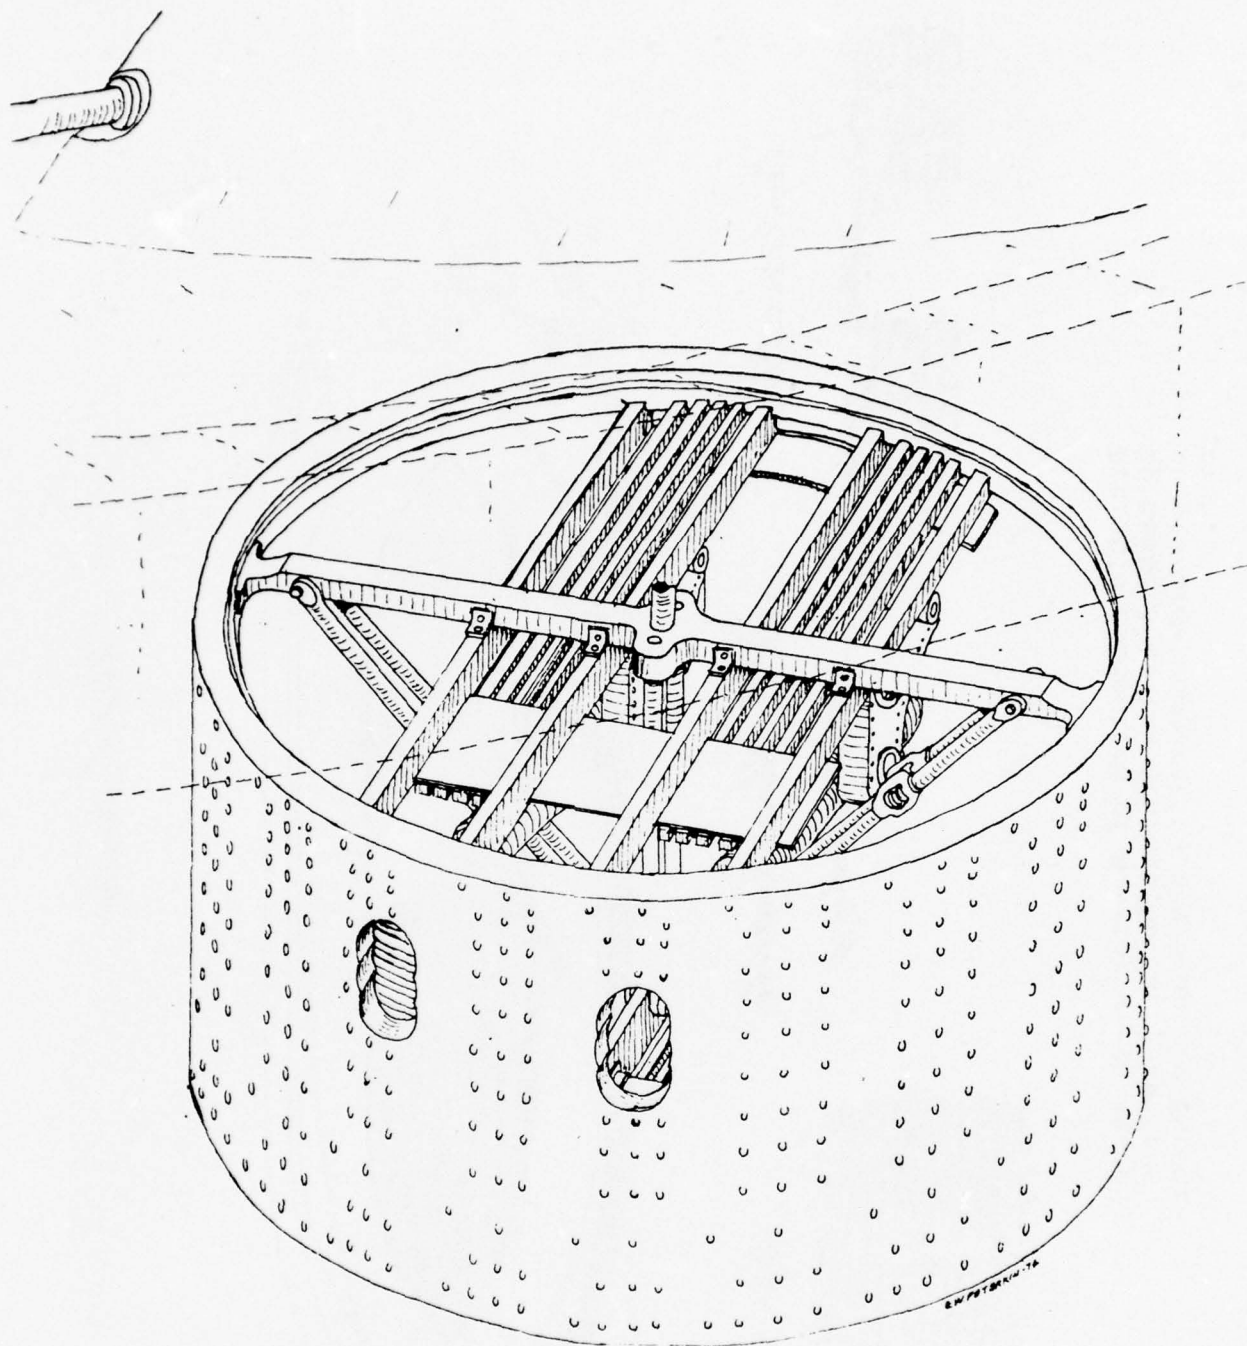
Drawing by Mr. E. W. Peterkin from original engineering drawings, of the Monitor turret inverted protruding from side of armor belt.

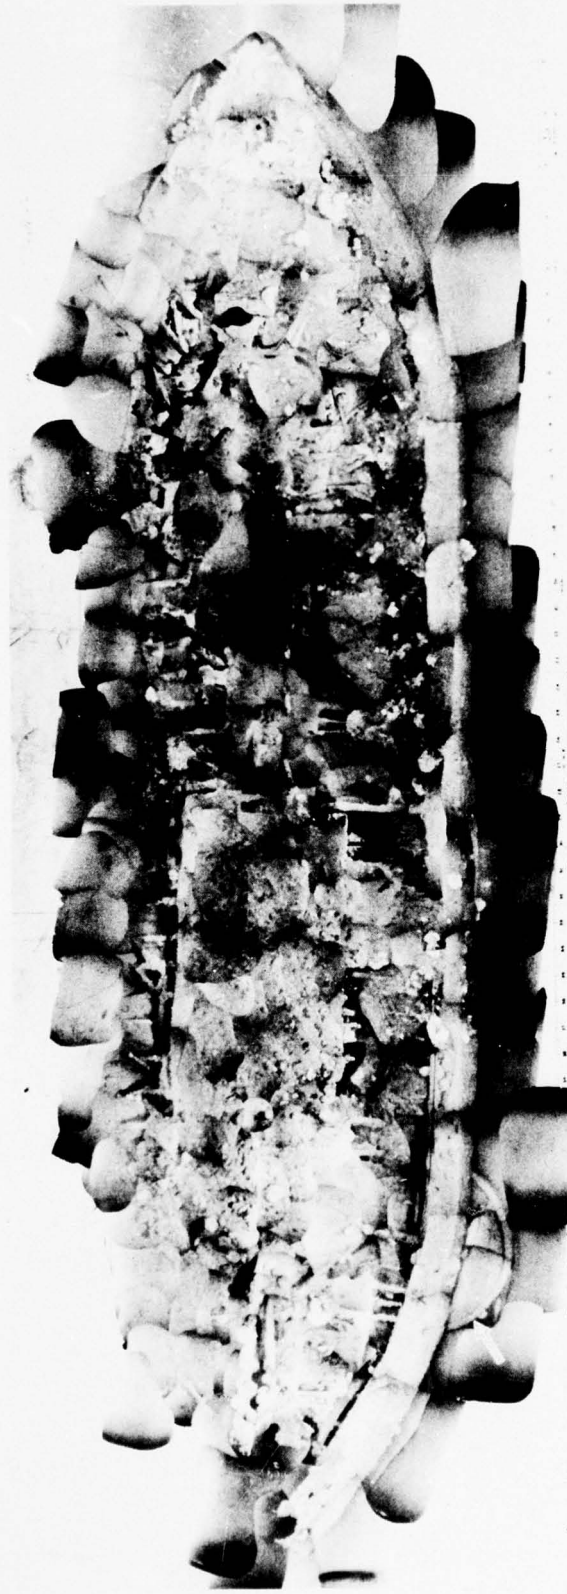
Final U. S. Navy photographic mosaic of the wreck of the Monitor. It took more than four months for photographic experts to assemble from the more than 1200 photographs that were taken on board the Seaprobe. The arrow points to the turret displaced to the stern and outboard of the wreck.

must have sheared off the deck when the ship sank to the bottom. A photomosaic of the hulk was assembled from the photographs and the following distinguishing characteristics were noted: (1) bow and stern shapes, (2) direction of the plating, (3) distinctive armor belt clearly visible, (4) peculiar diagonal braces used in the construction, (5) shape of skeg and extended propeller shaft position, (6) overall size of hull and general dimensions and (7) flat bottom. In addition, a portion of the underside of the turret was clearly visible and the thickness of the turret armor and turret dimensions were identical to specifications from original engineering drawings on loan from the Steven's Institute of Technology in Hoboken, New Jersey.

From the data collected, it is evident that the hulk is in a fragile condition, with 112 years of submersion in salt water taking its toll. However, it was noticed that the armor belt, constructed of oak with iron plating, was in surprisingly good shape and that the turret, constructed entirely of iron, was still intact.
